**Discrepant Paint-Baking Impact on  
AHSSs and HSAAAs Used in BEV  
Structures**

Jun Hu, PhD  
Cleveland-Cliffs Inc.

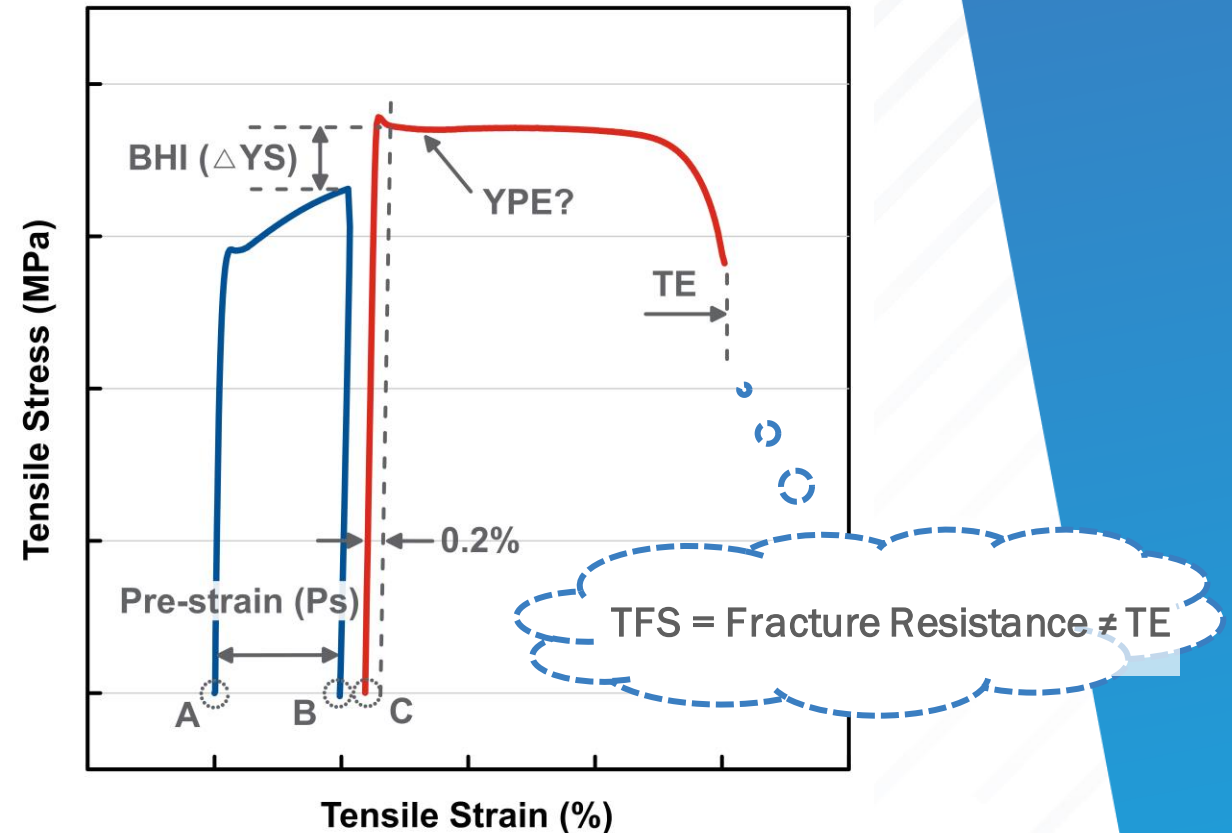
In 3 different case studies of this work:

- Various HSAs and AHSSs, various stress states
- Ps levels: 0/5/10/15%
- Strain rates: 0.001/1/10/100/1000 s<sup>-1</sup>
- Baking conditions: 170/200/250 °C,  $20 \pm 0.5$  min.
- Target parameters:  $\Delta YS$ , true fracture strain (TFS)

All the TFS results were processed via the hybrid method (SAE WCX 2022, GDIS 2023) based on 0.5 mm virtual strain gauge length (VSGL)

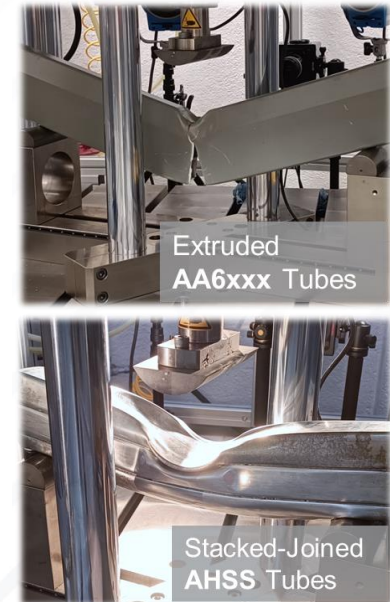
GI Q&P980 vs. AA6061-Tx:

- Cold-rolled TRIP-assisted multiphase 3G-AHSS grade vs. extruded Al-Mg-Si-(Cu) alloy
- Tubing via roll-forming-welding sheets vs. tubing via hot extrusion
- Baking after pre-strain (Ps) vs. baking without Ps
- Thickness 1.6 mm vs. 4.8 mm: similar strength-to-density ratio

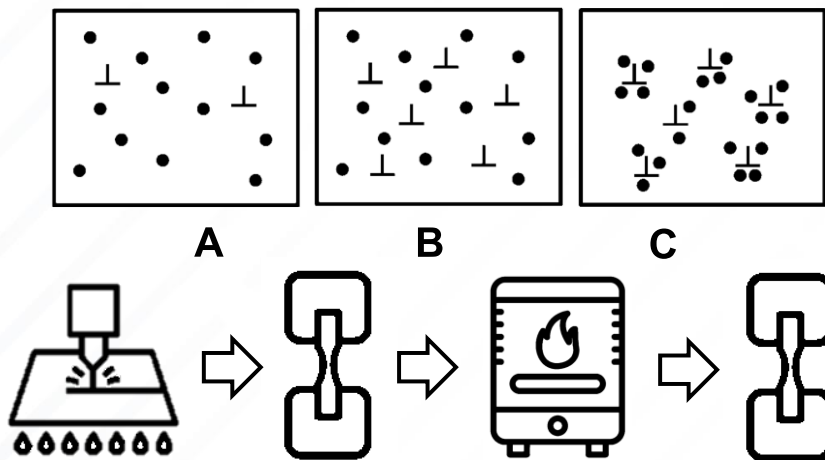
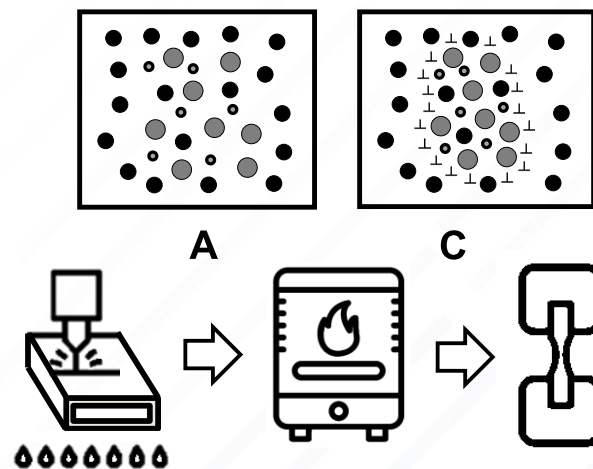
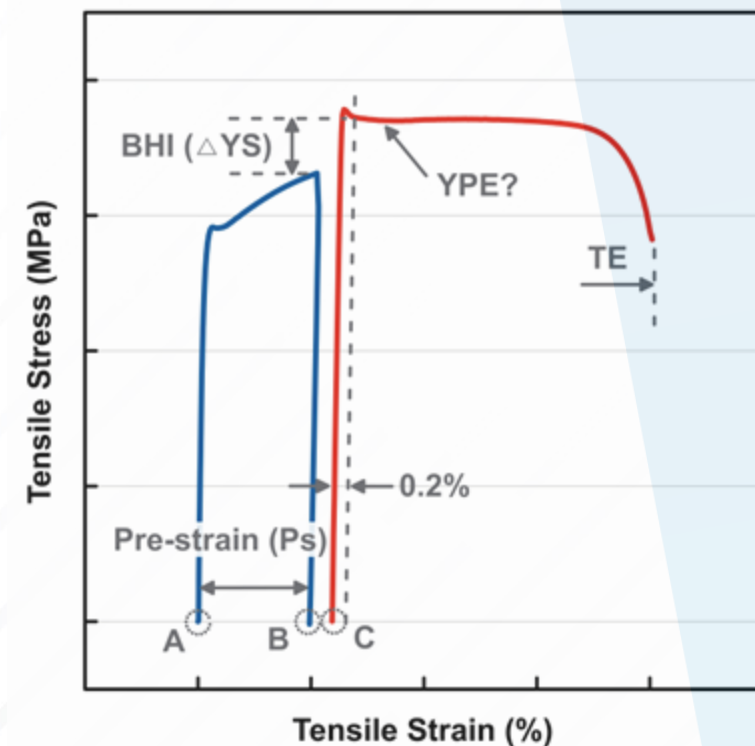
## Comparison of Procedures and BH Mechanisms

Q&P980 BH mechanism(s):

- ‘Cottrell atmospheres’
- Martensite tempering
- Carbides precipitation in ferrite
- ...

AA6061-Tx BH mechanism(s):

- Impurities precipitation (aging)

Need longer baking time and/or higher temp. to accentuate

⊥ Dislocation • Interstitial atom (C, N)

● Al atom ● Mg atom ○ Si atom

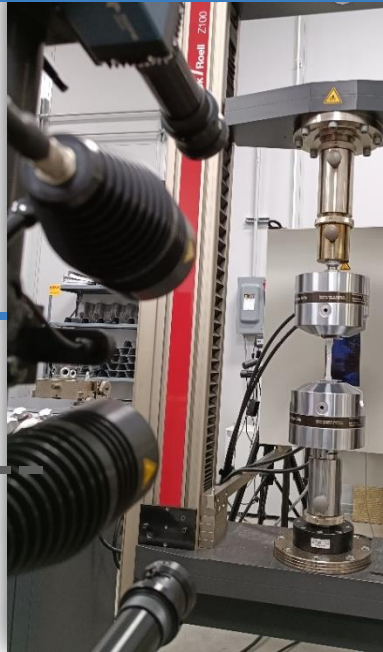
Ps/unload ASTM E8 longitudinal samples at 0.001/s → bake at 170 °C for 20 min. → reload at 0.001/s to fracture → post-process ΔYS and TFS

DIC real-time strain control

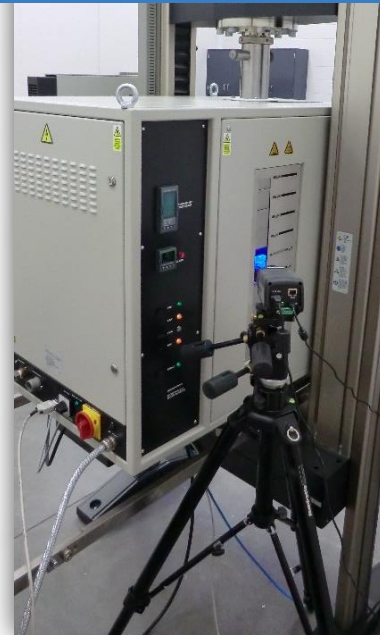
Infrared thermal camera in-situ temperature monitor

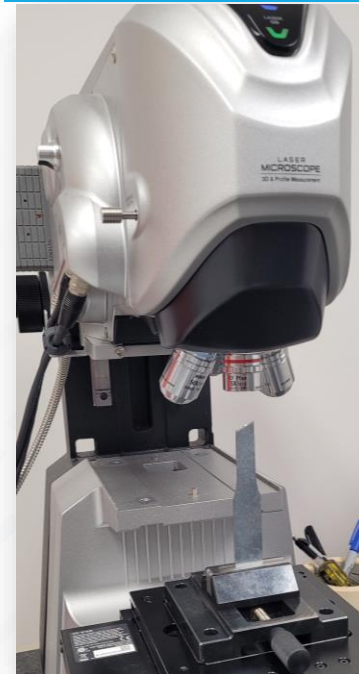
TFS measurement

$$\bar{\epsilon}(vM) \approx \sqrt{\frac{2}{3}(\epsilon_1^2 + \epsilon_2^2 + \epsilon_t^2)}$$

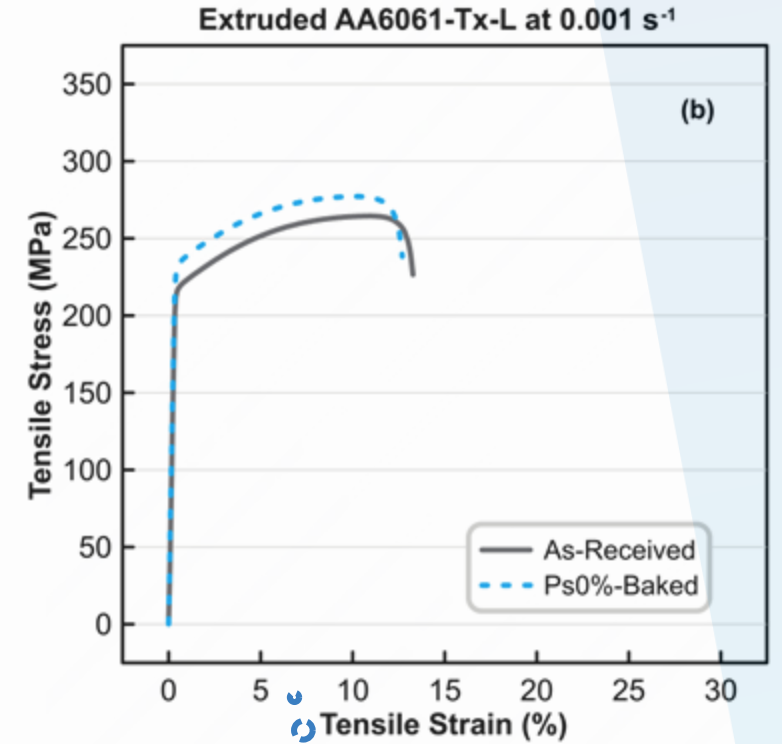
# 1) Quasi-Static Tensile: Results

Q&P980 vs. AA6061-Tx: baking affected  $\Delta$ YS and TFS

YS: strain accumulated dislocations saturate at a low Ps level  
 TFS: fracture mainly induced by the transformed martensite

Baking = continued artificial aging

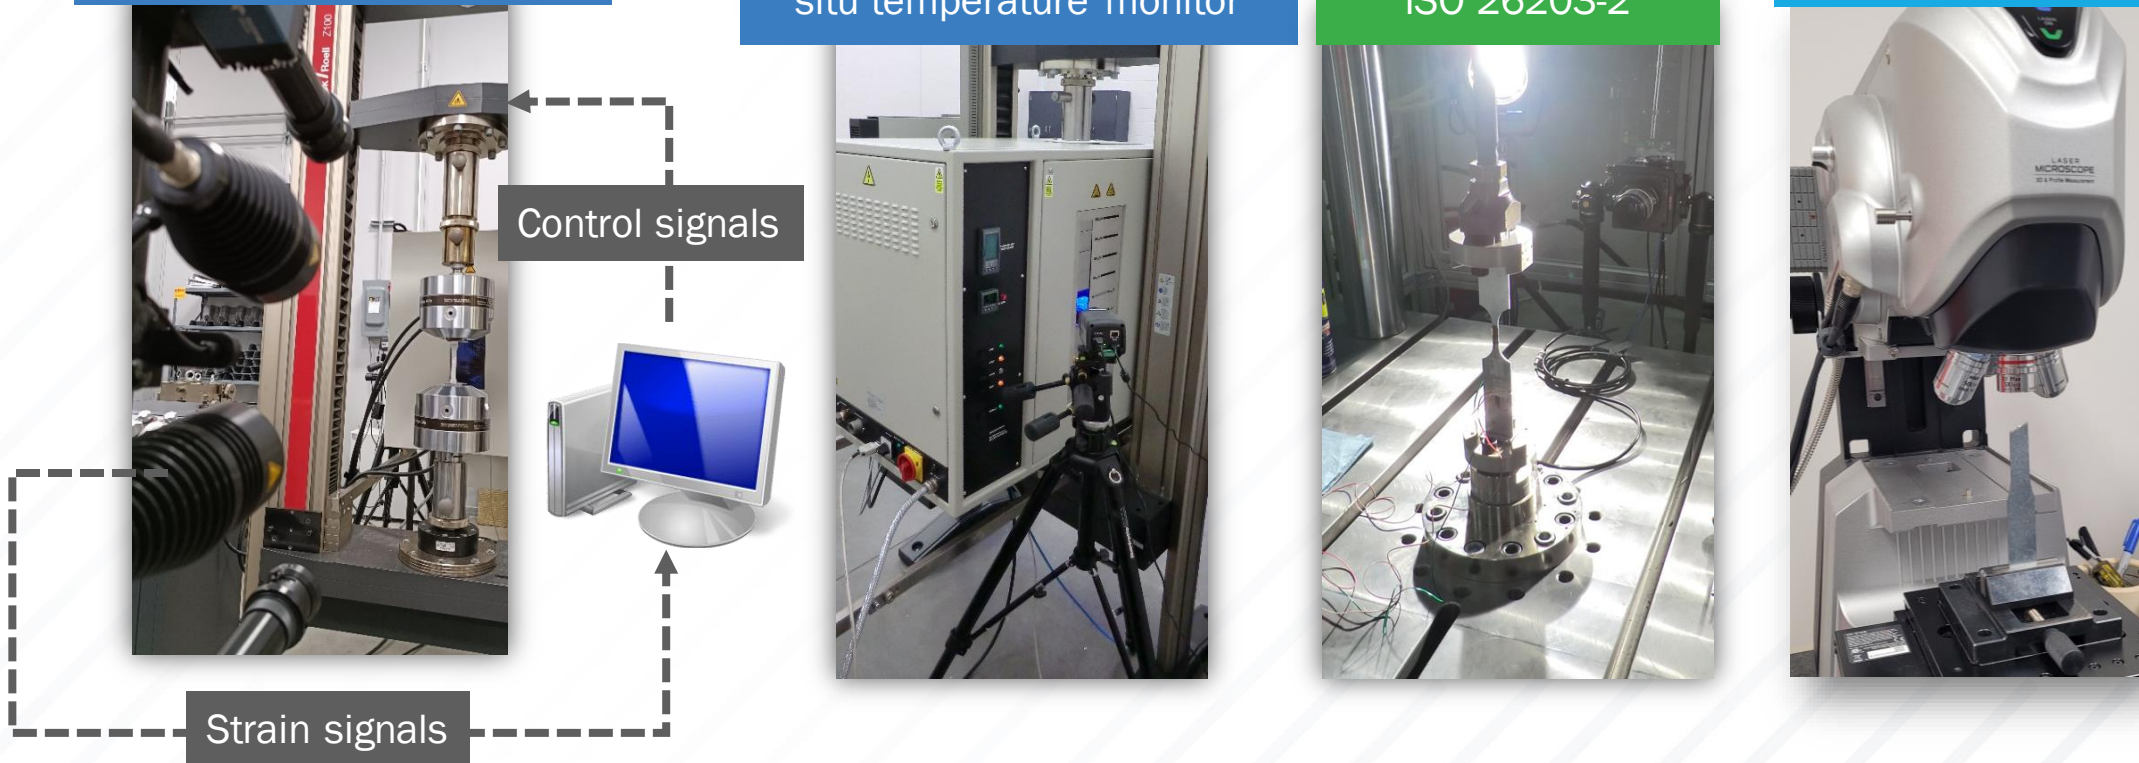
## 2) Rate-Dependent Tensile: Setup & Procedure

Ps/unload downsized samples at 0.001/s → bake → reload at 1/10/100/1000 s<sup>-1</sup> to fracture → post-process ΔYS and TFS

DIC real-time strain control

Infrared thermal camera in-situ temperature monitor

HSR testing based on ISO 26203-2

TFS measurement

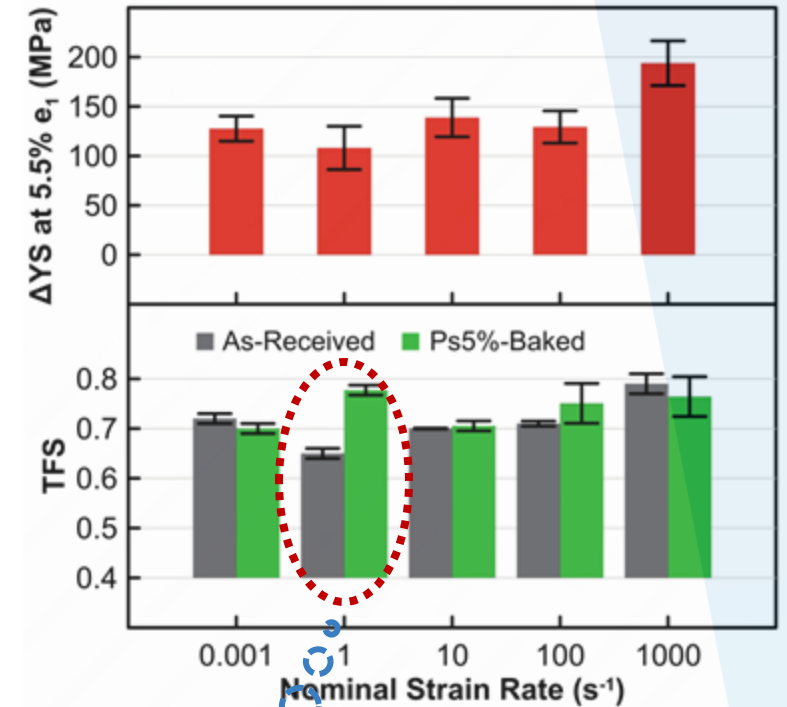
GI Q&P980-L

★  $\Delta YS = Ps\text{-baked } 0.2\%_{\text{offset}} YS - As\text{-received } 5.5\% \text{ stress}$ 
★

The BH samples dissipated additional adiabatic heat that activated the favoring temperature range of the TFS

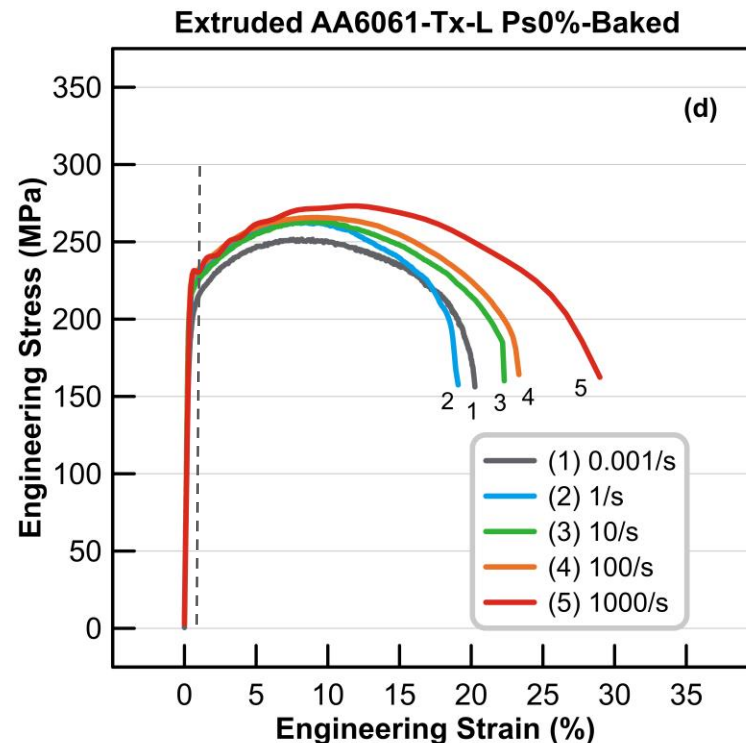
## 2) Rate-Dependent Tensile: AA6061-Tx Results

When the SR ↑, the  $\Delta YS$  + yet unstable; the TFS + yet suppressed by the baking

$$\Delta YS = \text{Ps-baked } 0.2\%_{\text{offset}} \text{ YS} - \text{As-received } 0.2\%_{\text{offset}} \text{ YS}$$

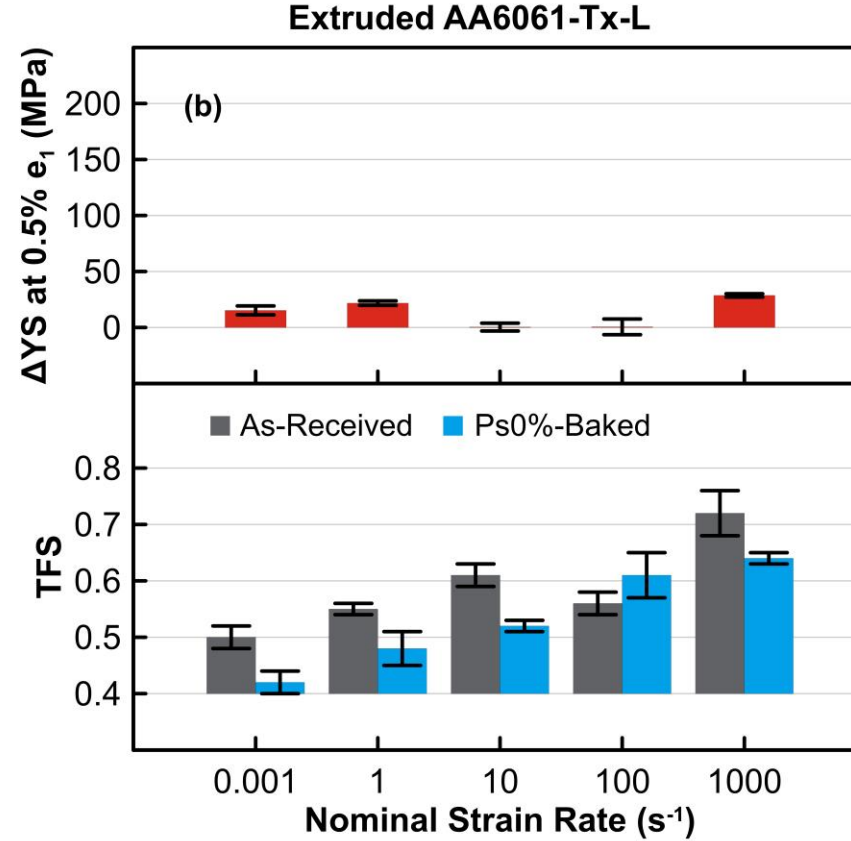
# 2) Rate-Dependent Tensile: Comparison

Q&P980 vs. AA6061-Tx after the Ps-baking

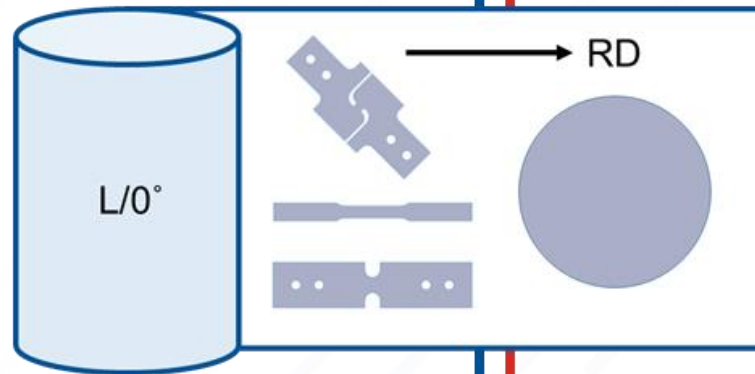
# 3) Stress-State-Dependent Tests: Setup & Procedure

Ps/unload various samples at 0.001/s → bake → reload at 0.001/s to fracture → post-process TFS

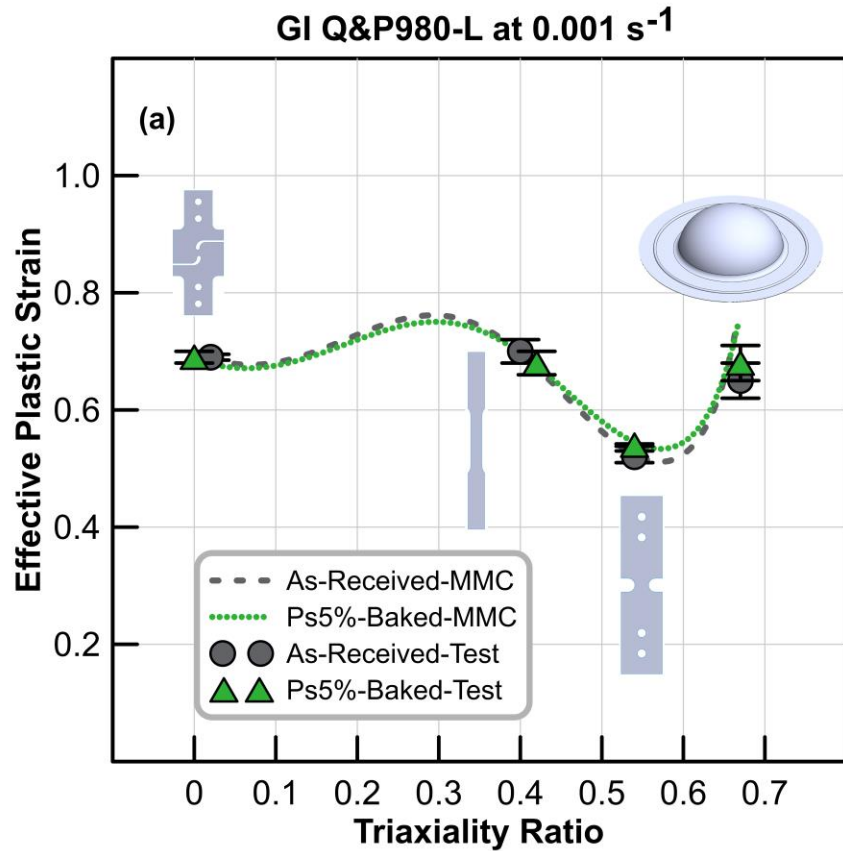
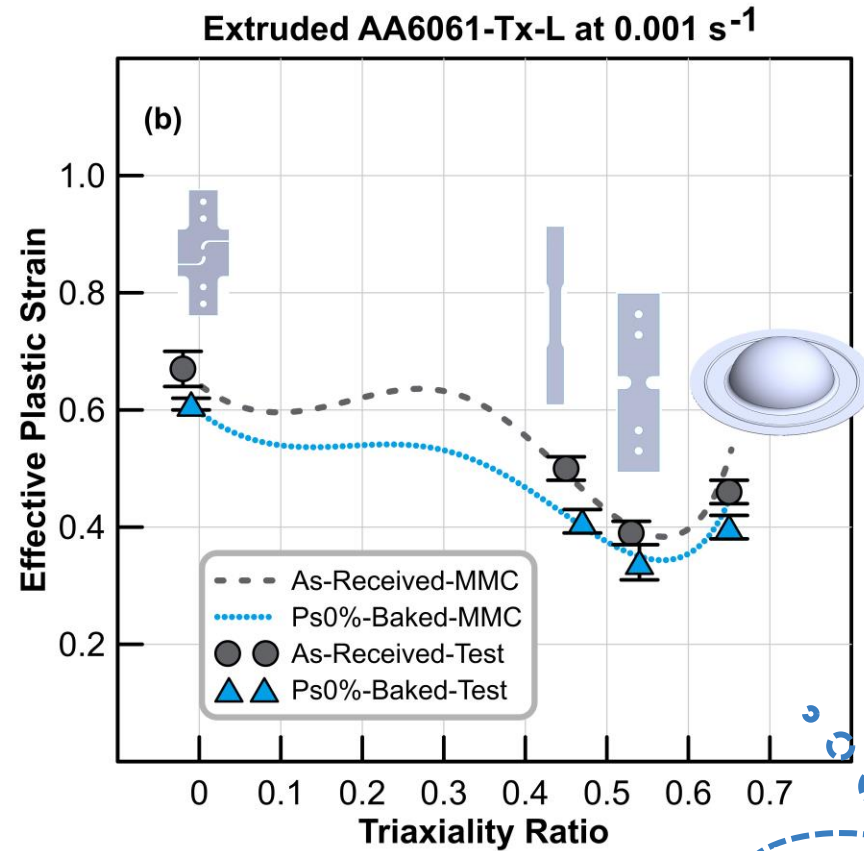
# 3) Stress-State-Dependent Tests: Results

Q&P980 vs. AA6061-Tx: TFS loci (fracture resistance at different stress states)

CAE engineers need to update the material cards for crash simulations

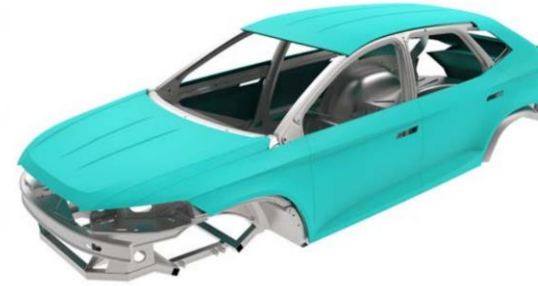
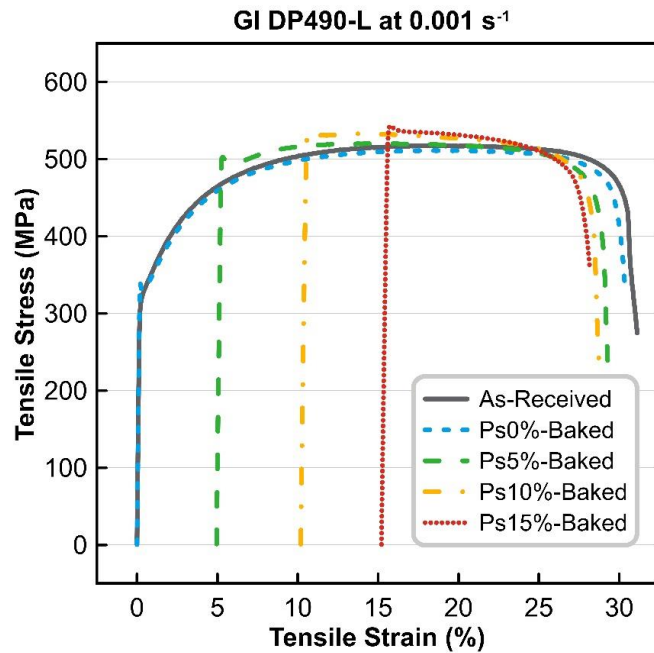
## Case Study II Abstract: Exposed Panels

GI DP490 vs. AA6451-T4:

- Ps levels: 0/5/10/15%
- Strain rates: 0.001/1/10/100/1000 s<sup>-1</sup>
- Baking conditions: 170 °C, 20 min.
- Target parameters:  $\Delta$ YS, TFS

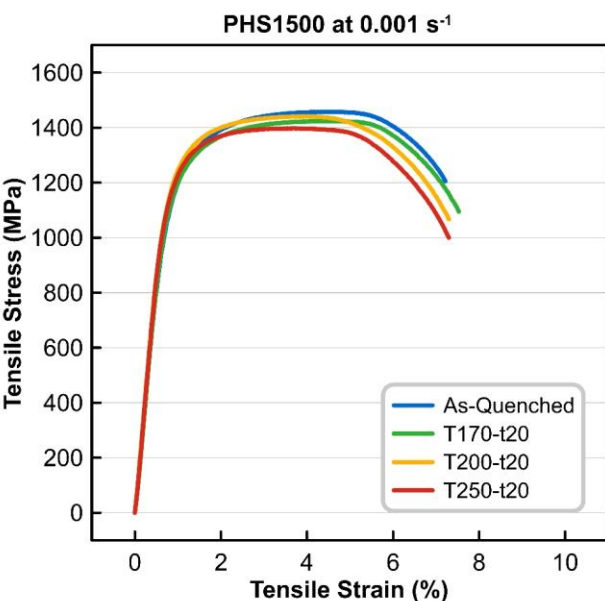
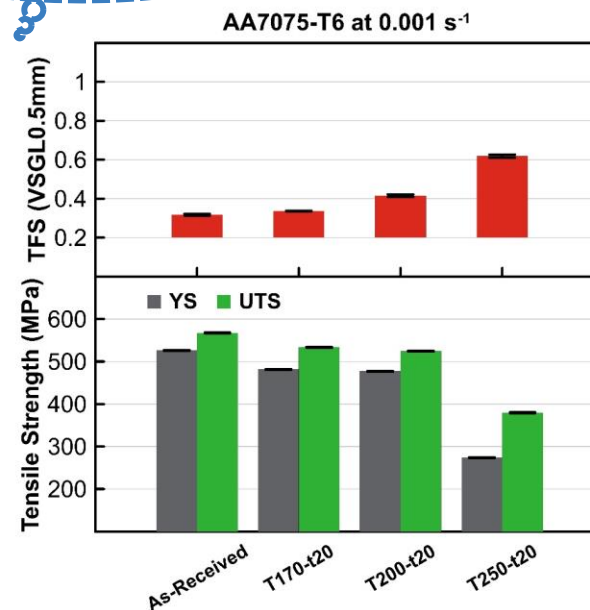
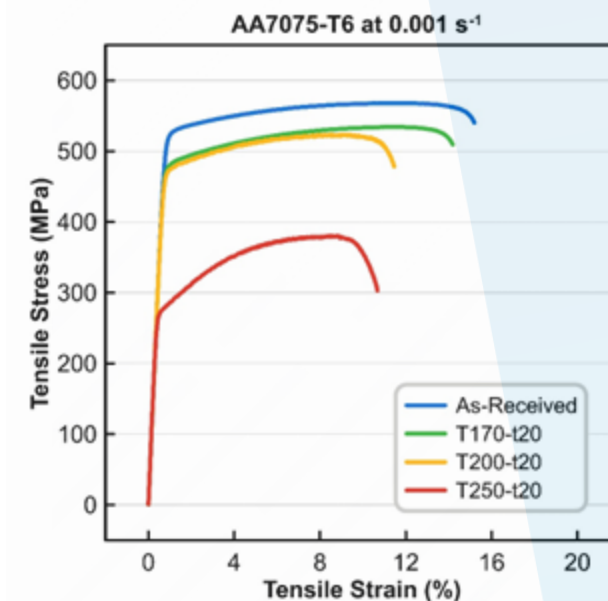
Al-Si PHS1500 vs. AA7075-T6:

- Ps levels: 0%
- Strain rates:  $0.001 \text{ s}^{-1}$
- Baking conditions: 170/200/250 °C, 20 min.
- Target parameters: YS, UTS, TFS

Martensite tempering vs. over-aging

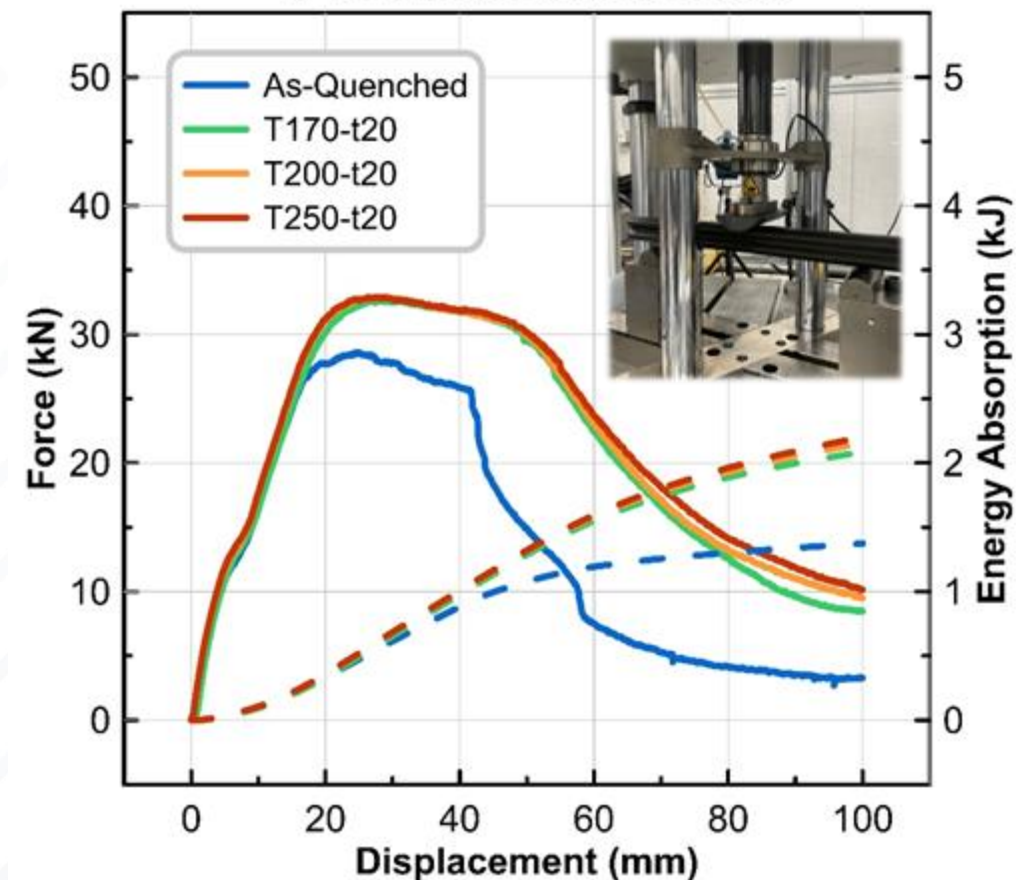
3PB on PHS1500 at 10 mm/s

Photos were captured after delayed fracture, courtesy of E. Hernandez-Duran

### 3-Point-Bending on PHS1500 Tubes
