GREAT DESIGNS IN **STEEL**

Additive Metals - Phase II, Direct Energy Deposition(D.E.D.)

General Motors Company

(Presenting for Auto/Steel Partnership)

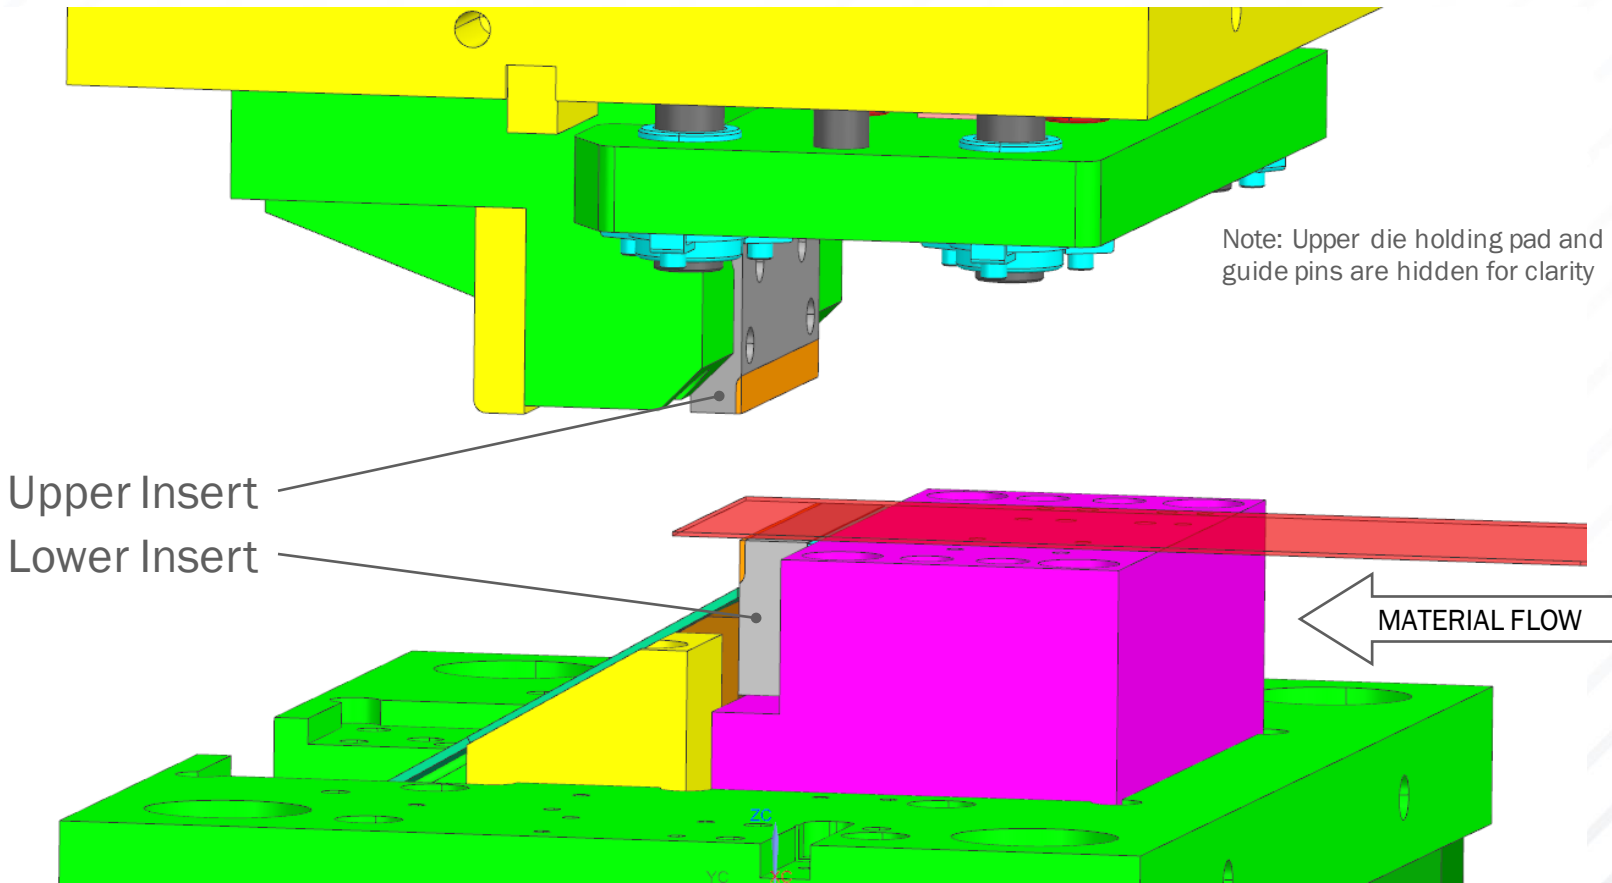
Stamping Die for Trim Material Testing

- Participants:
 - FormAlloy
 - GM Flint Tool & Die
 - Oakland University
- Approach:
 - Fabricate a pair of trim inserts (one upper, one lower)
 - Pre-hardened 4140 substrate with M2 powder DED at the trim edge
 - Conduct a trial of 50,000 hits
 - Stamping die trial using DP980 1.4mm thick sheet steel at Oakland University
 - Analyze the Condition of the insert and sheet metal parts
 - At predetermined increments, the inserts will be analyzed and photographed for wear.
 - The sheet metal parts will be monitored for defects.

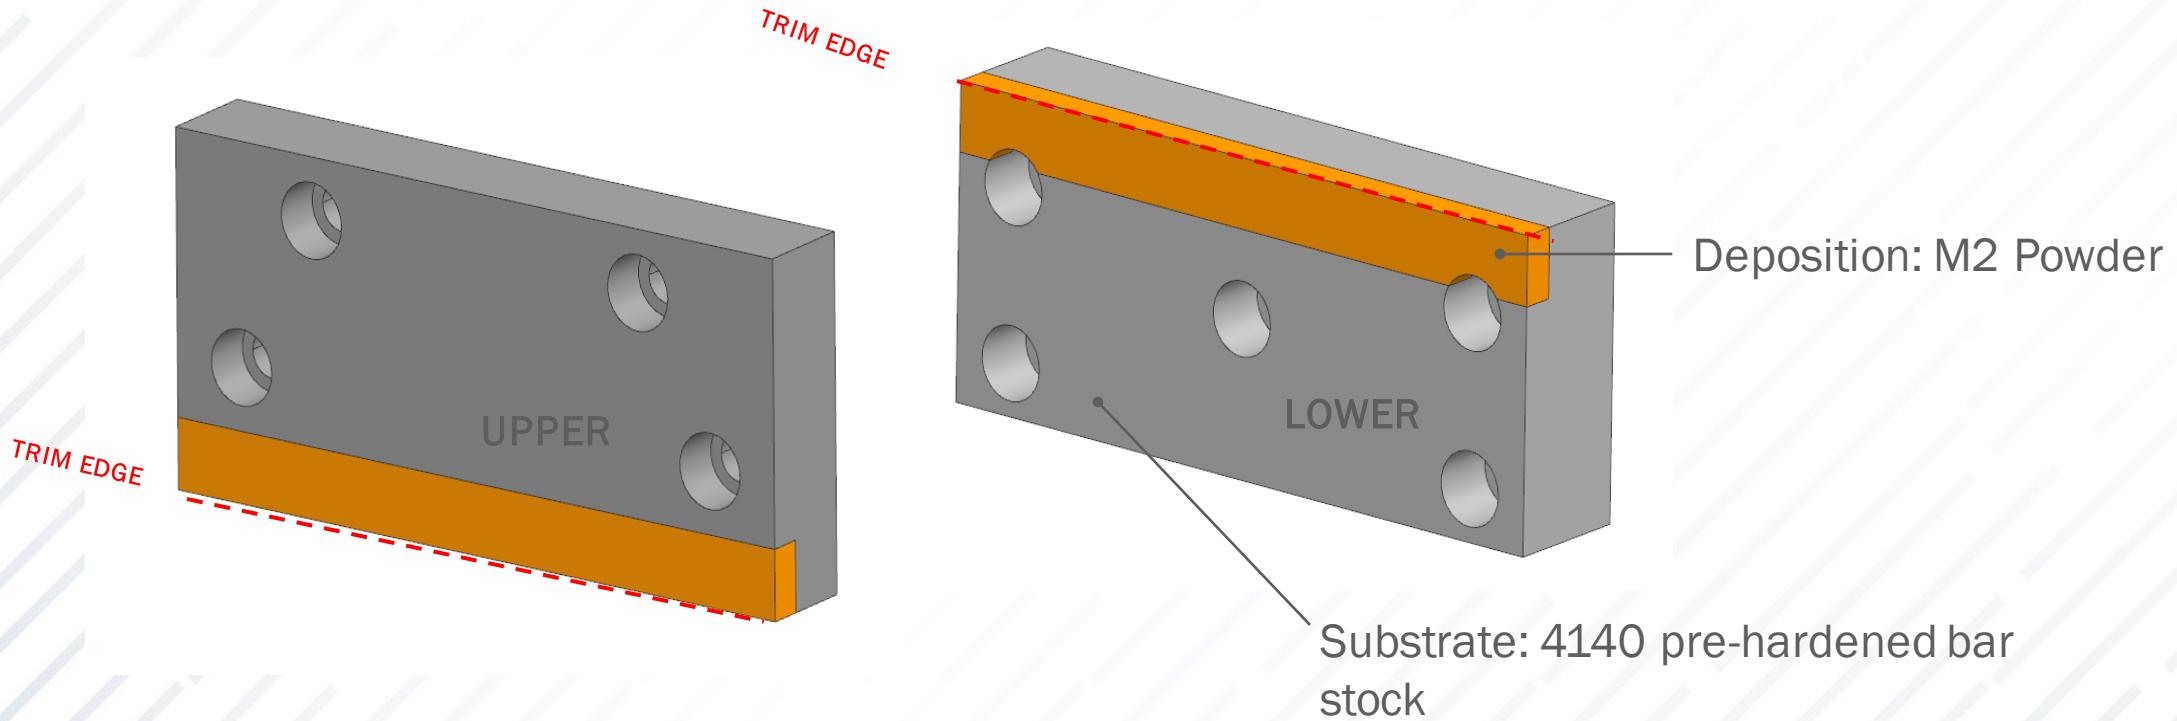
Project Approach – Materials Studied:

2 basic trim inserts were manufactured for testing, 1 for the lower die and 1 for the upper die

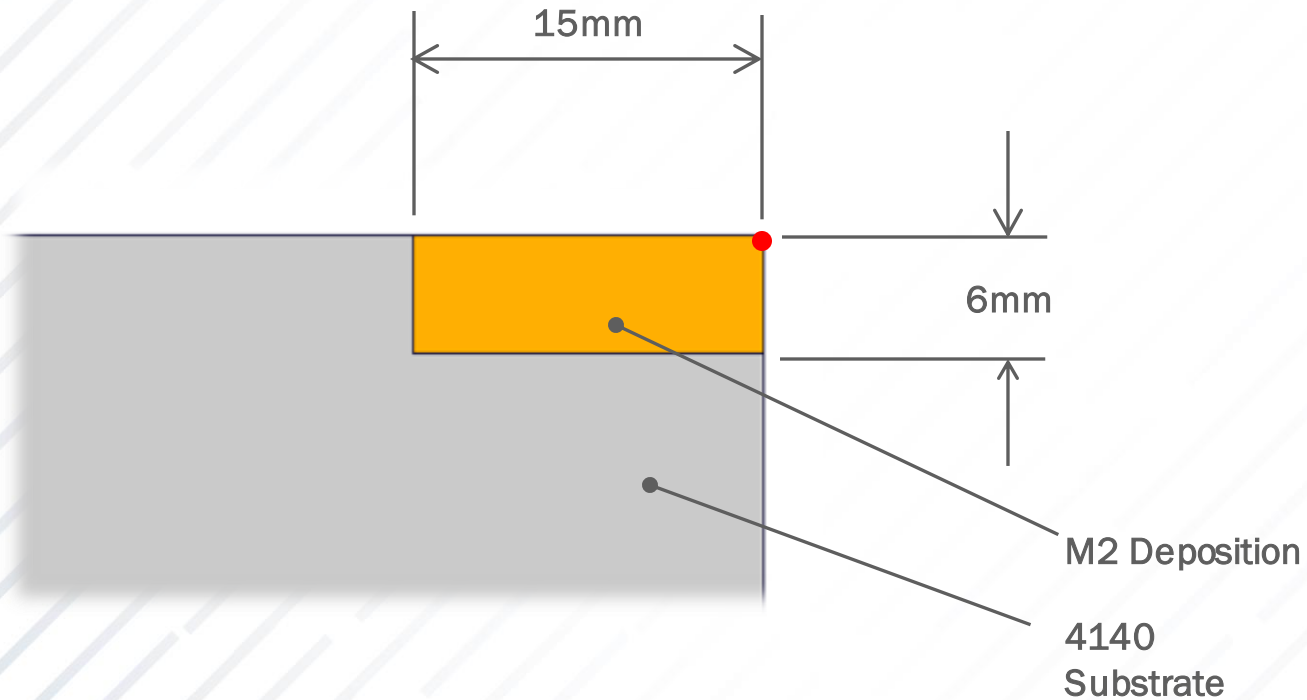
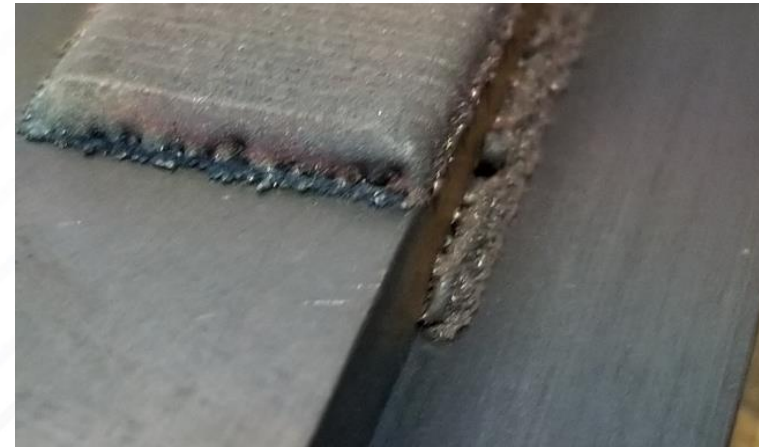
Project Results: Trim Insert Design – 1st Attempt

For the first attempt a standard end mill was used to cut a groove in the 4140 substrate. Depositing the M2 powder into a 90° corner was an issue with the printer we had available.

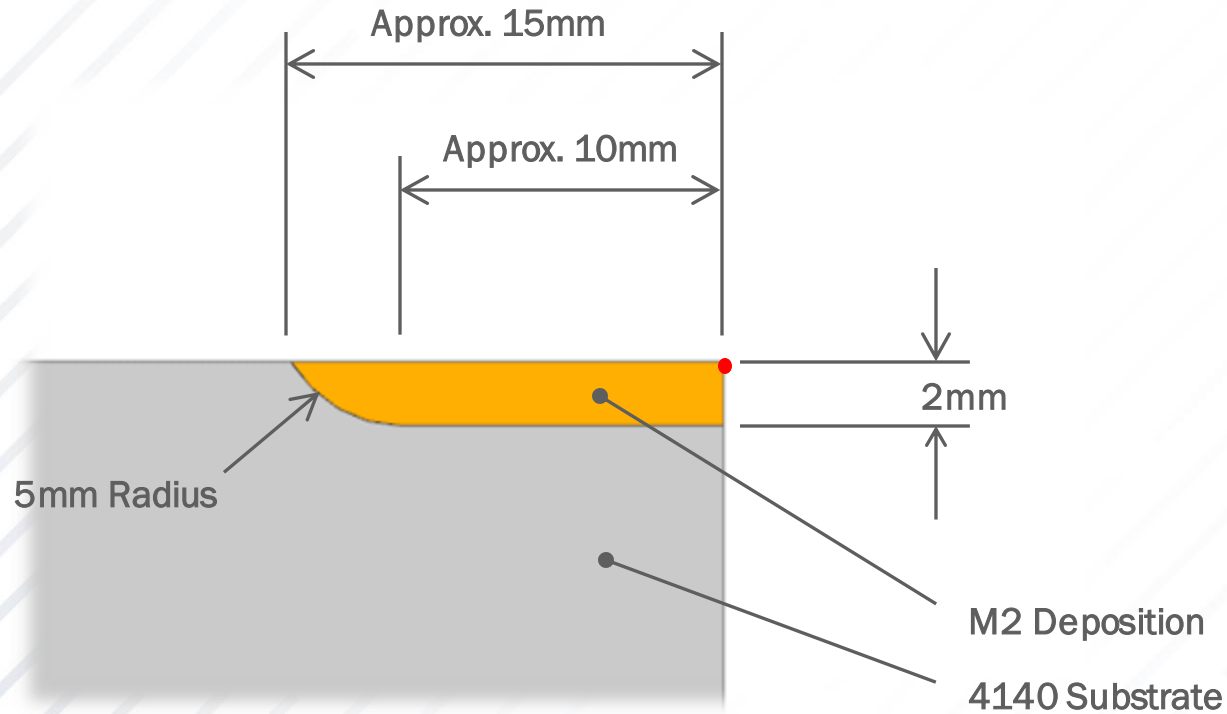
Project Results: Trim Insert Design – As Tested

- 1mm of material was added to the front and top of the trim inserts for final machining
- 10mm diameter ball nose cutter was used to leave a 5mm radius where the deposition transitions back to the substrate
- 15mm is a standard dimension for the depth of trim edge on an insert using standard manufacturing practices

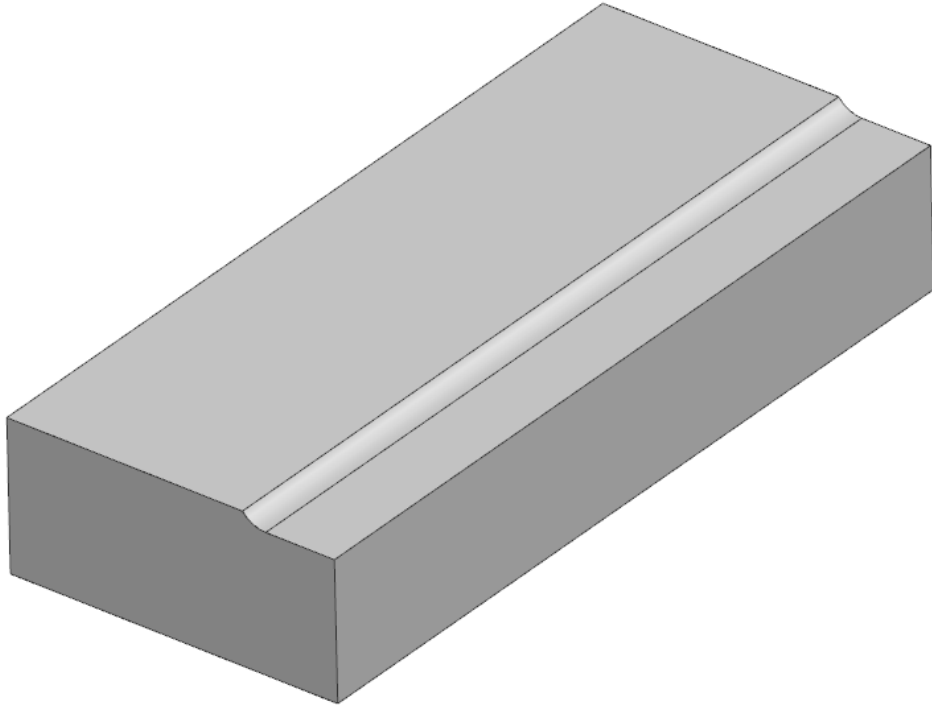
Trim Insert – Preheating Prior to Deposition

Substrates were pre-heated prior to deposition. An induction heater was used at 90% power to heat up the insert to 315°C (600°F) and held at that temperature for 30 seconds.

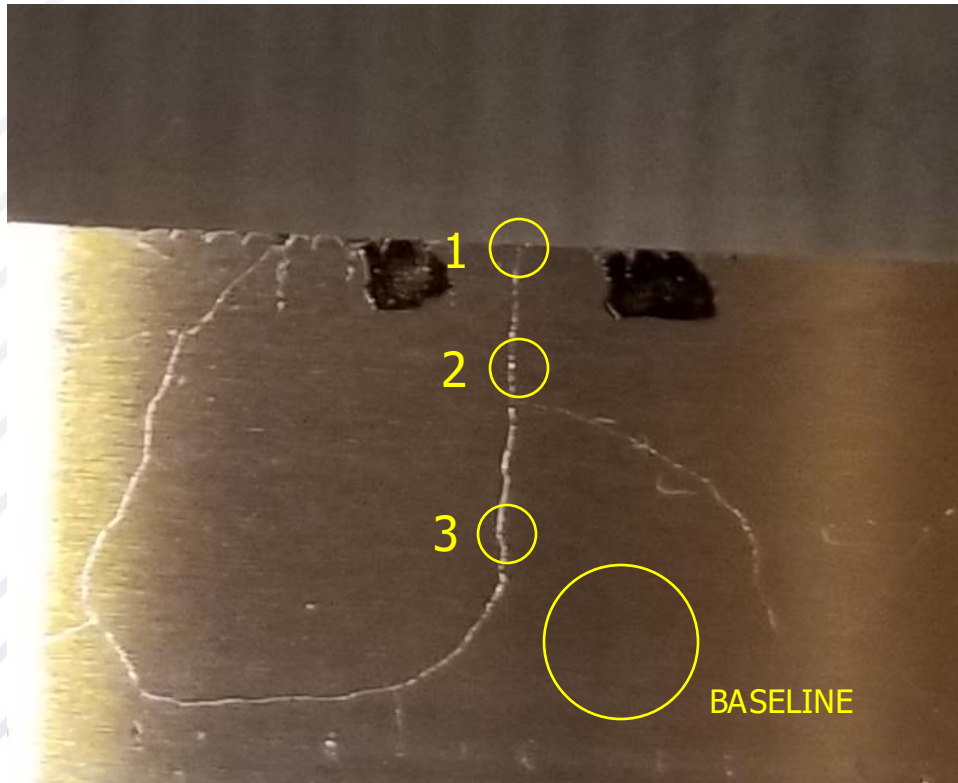
Pre-Test: 3D Microscopy of Visible Cracks

After finish machining several cracks were visible in the deposited M2 material. The cracks in the lower insert were more severe than the upper insert.

CT scans of the cracks were taken before running the 50,000-hit test for comparison after the test.

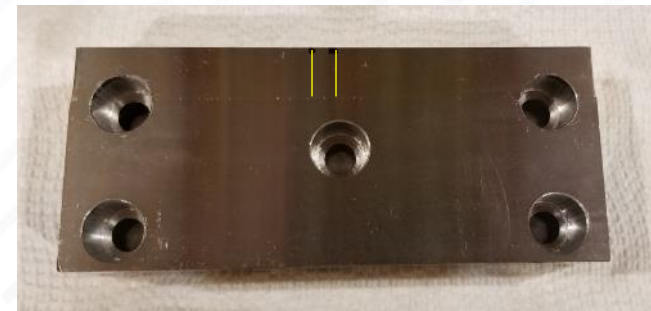
crack that was scanned
is between the lines

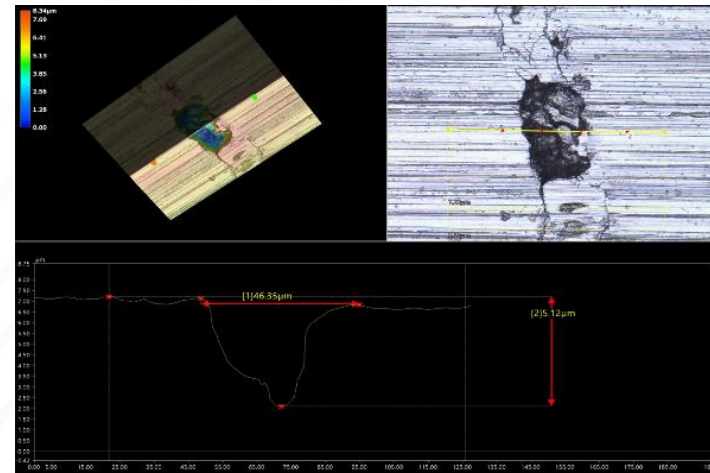
SCAN POINT #3

46.3 μm Wide, 5.1 μm Deep

Pre-Test: 46.3 μ m Wide, 5.1 μ m Deep

Post-Test: 38.7 μ m Wide, 3.8 μ m Deep

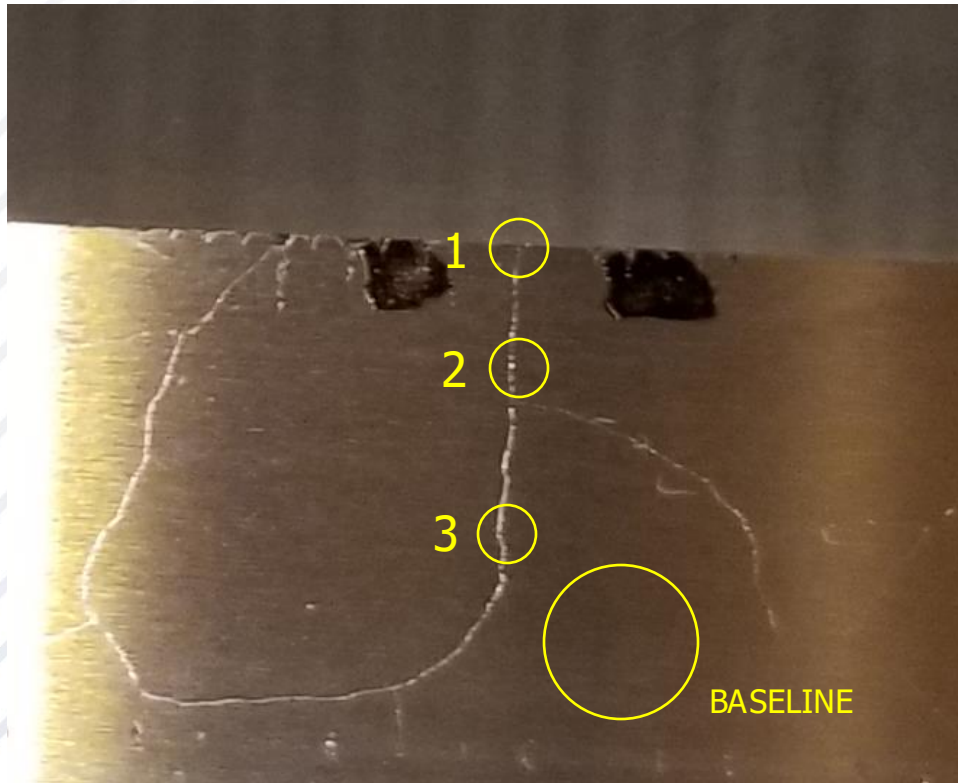
Crack Depth Analysis – Lower Insert Results

1.5 μm = Baseline Surface Roughness

139.9 μm Wide, 12.4 μm Deep

44.3 μm Wide, 3.5 μm Deep

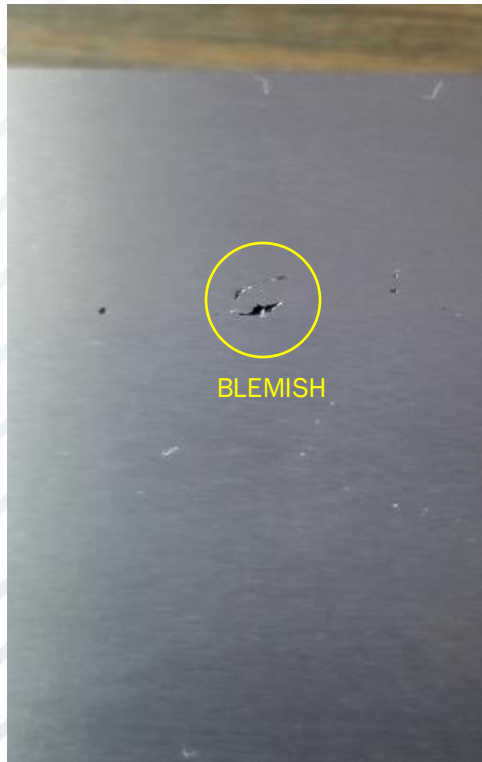
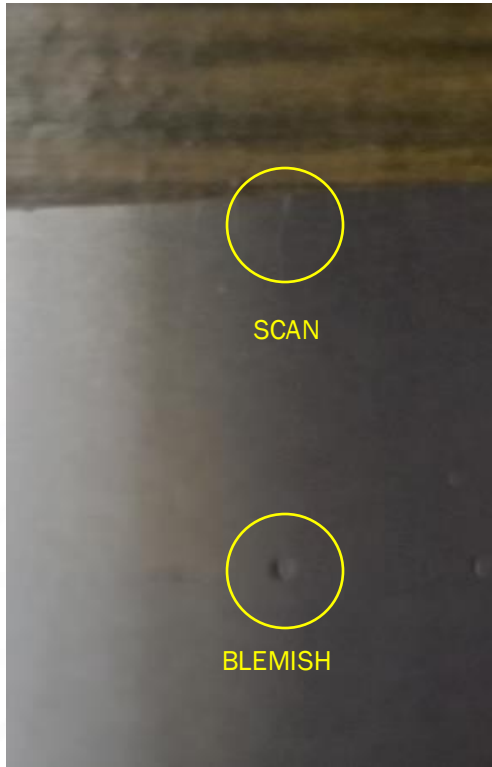
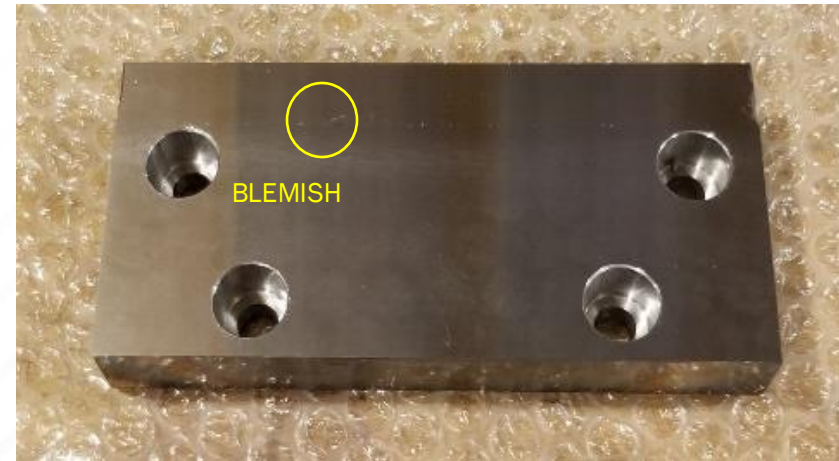
Pre-Test: 3D Microscopy of Visible Cracks

The cracks on the upper insert were far less severe
(hard to see and photograph)

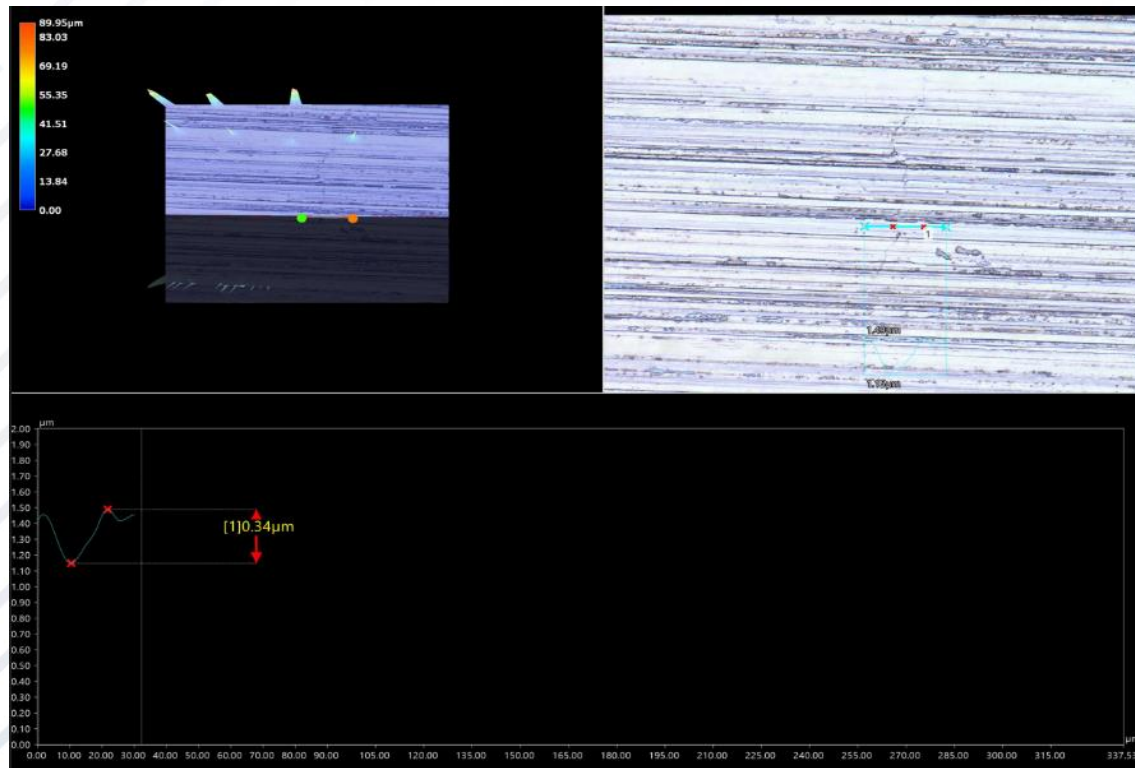
Crack Depth Analysis – Upper Insert Results

0.34 μm = Baseline Surface Roughness

0.87 μm = depth of crack (single scan)

The cracks in the upper were deemed insignificant.

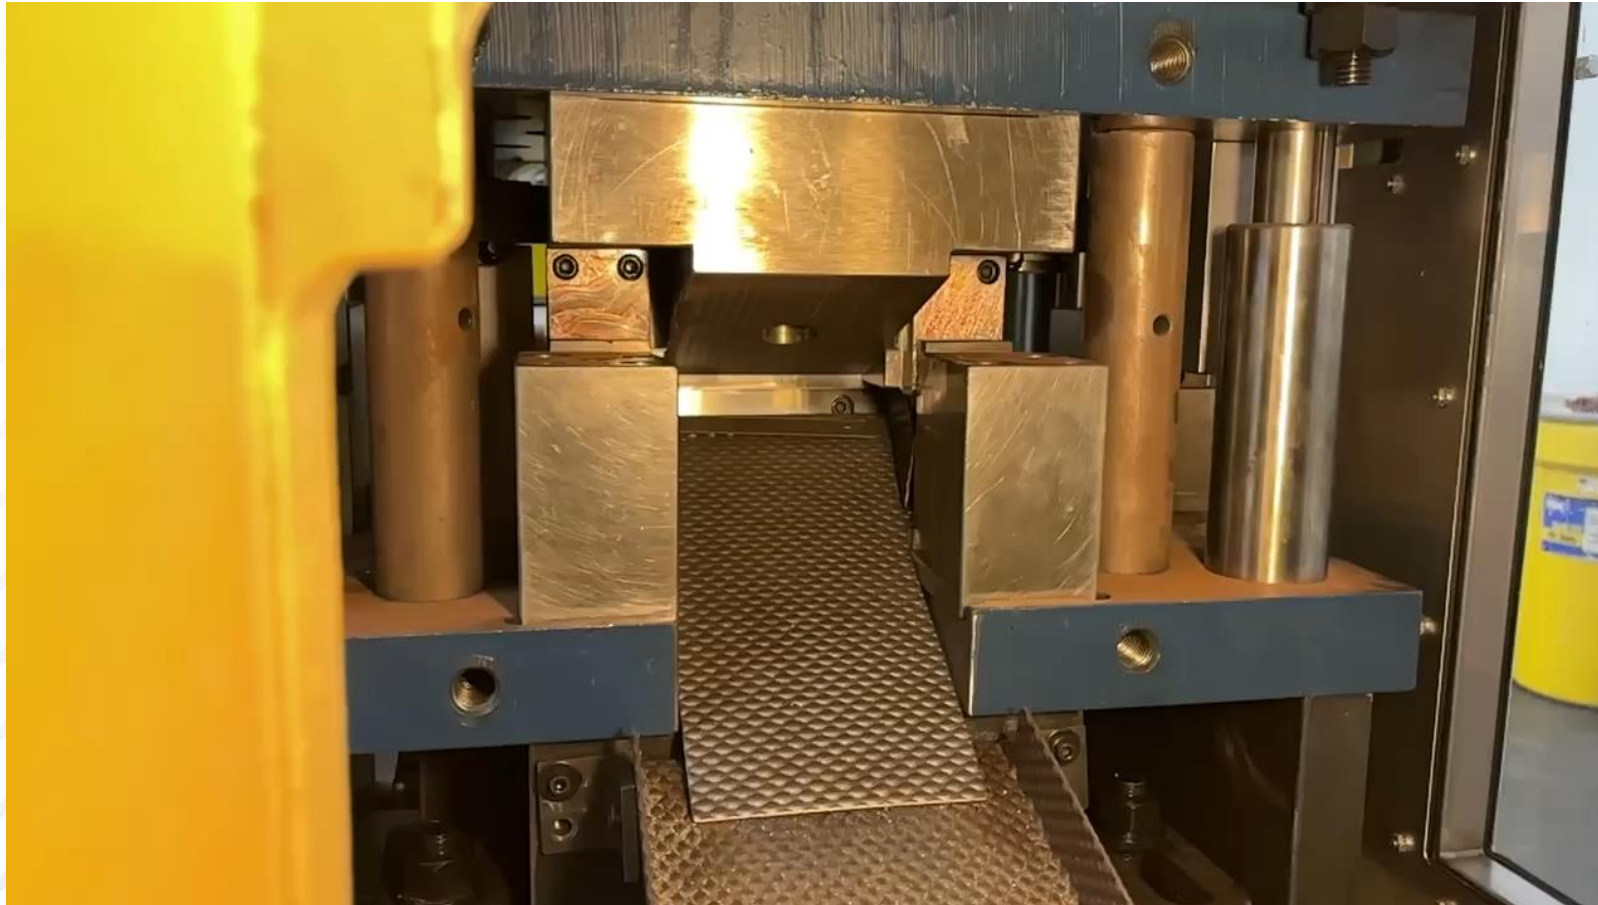
Test Component Processing

50,000 hits on DP980 sheet steel at Oakland University

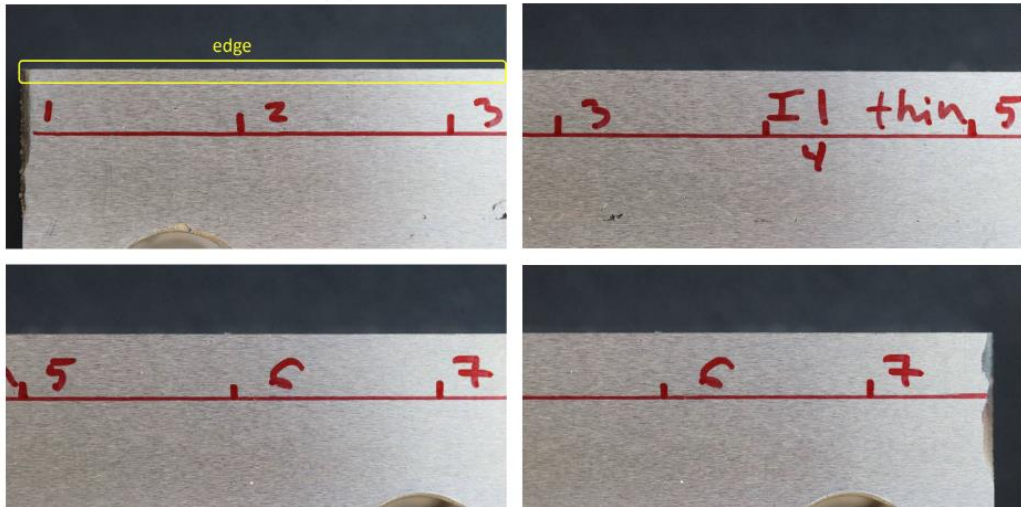
Upper Insert Initial Condition

The edge of the inserts were divided into 7 different zones for analysis. Pictures of die inserts were taken as a baseline before testing, then after every 1000 hits, until 5000 hits have been reached. After 5000 hits have been completed, pictures were taken after each additional 5000 hits up to 50,000. If there was a noticeable change to the sheet metal part, the test would be stopped, and pictures of the insert would be taken at that point.

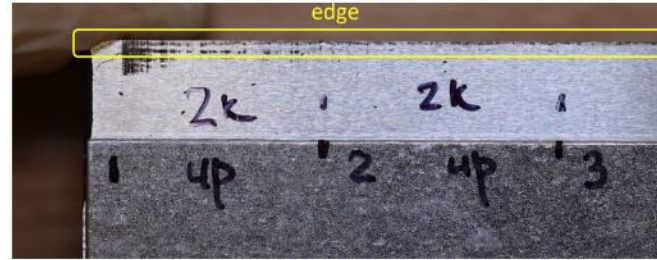
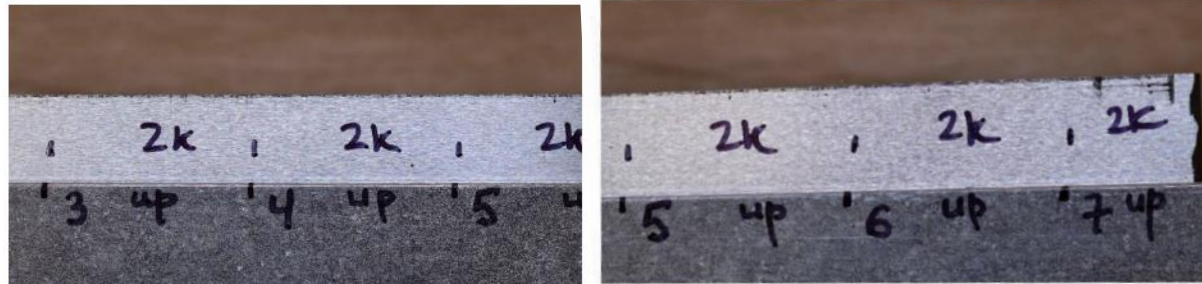
Trim Insert Testing Results

- About 1400 – 2000 hits, a part of the insert chipped out on the edge of the upper insert.
- There were no burrs or defects detected in the test components.

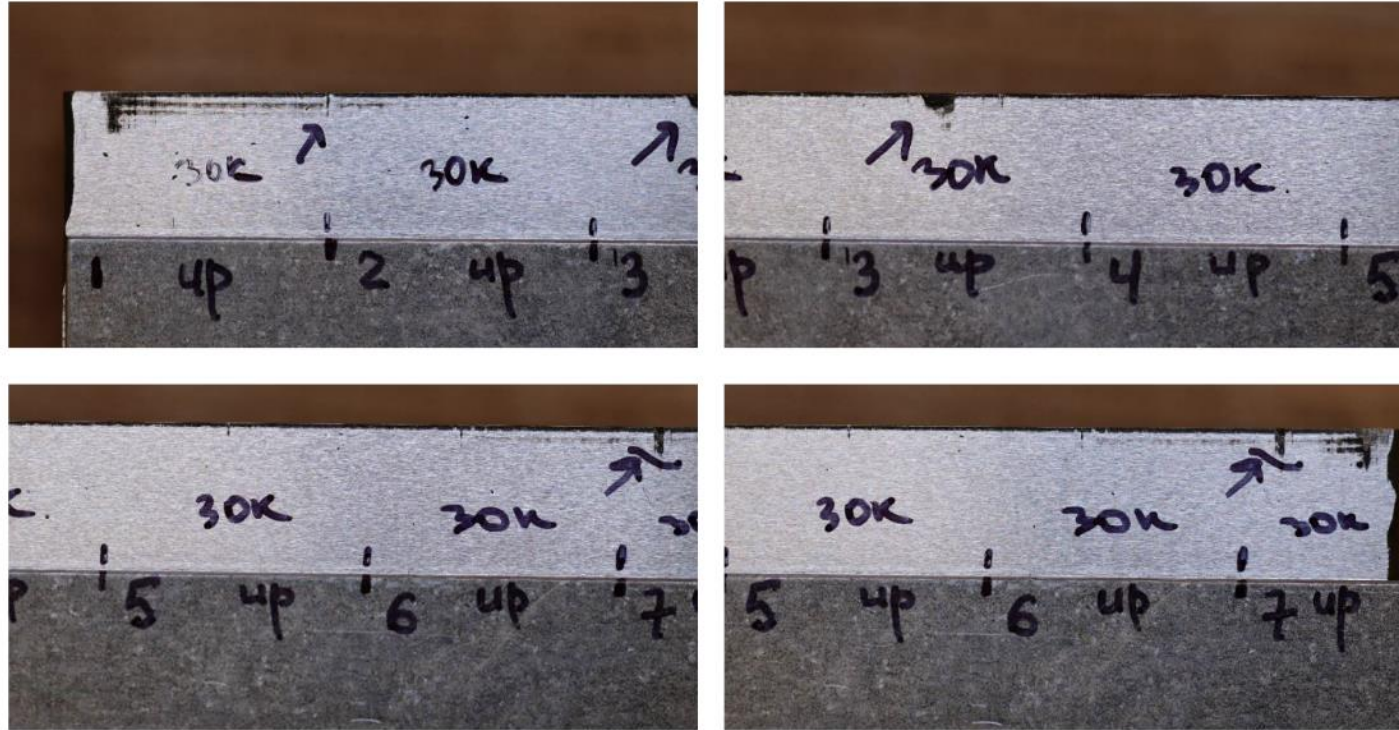
Upper Insert at 27,000 hits

- About 27,000 hits, a part of the insert chipped out towards the middle of the upper insert.
- There were no burrs or defects detected in the test components.

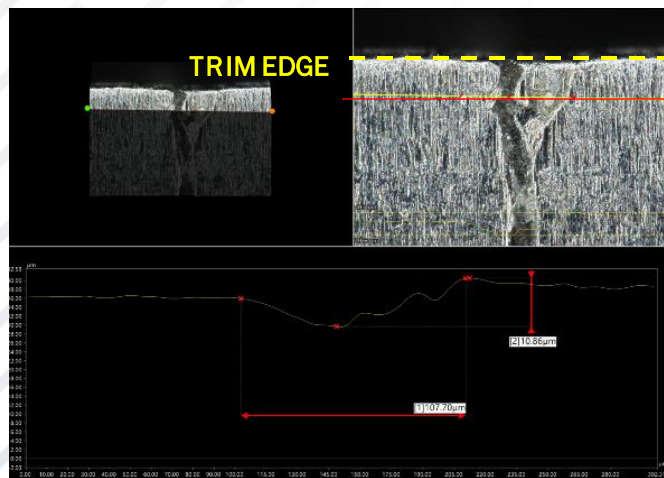
SCAN POINT #1

The width and depth of the cracks were measured using a Keyence VHX-7000 at 1000x magnification.

SCAN POINT #1:

Pre-Test: 139.9 μ m Wide, 12.4 μ m Deep

Post-Test: 117.7 μ m Wide, 10.8 μ m Deep

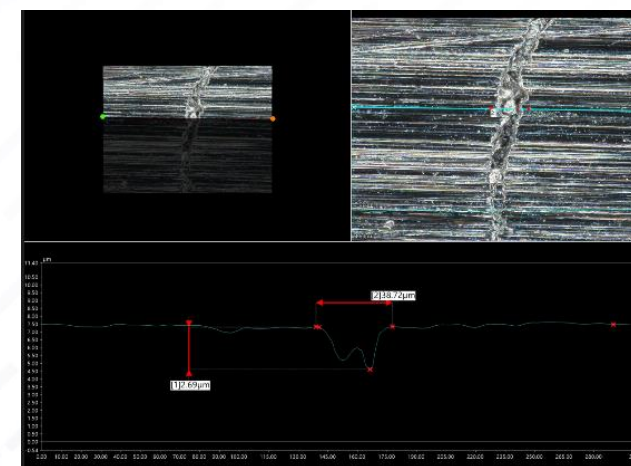
SCAN POINT #3

SCAN POINT #3:

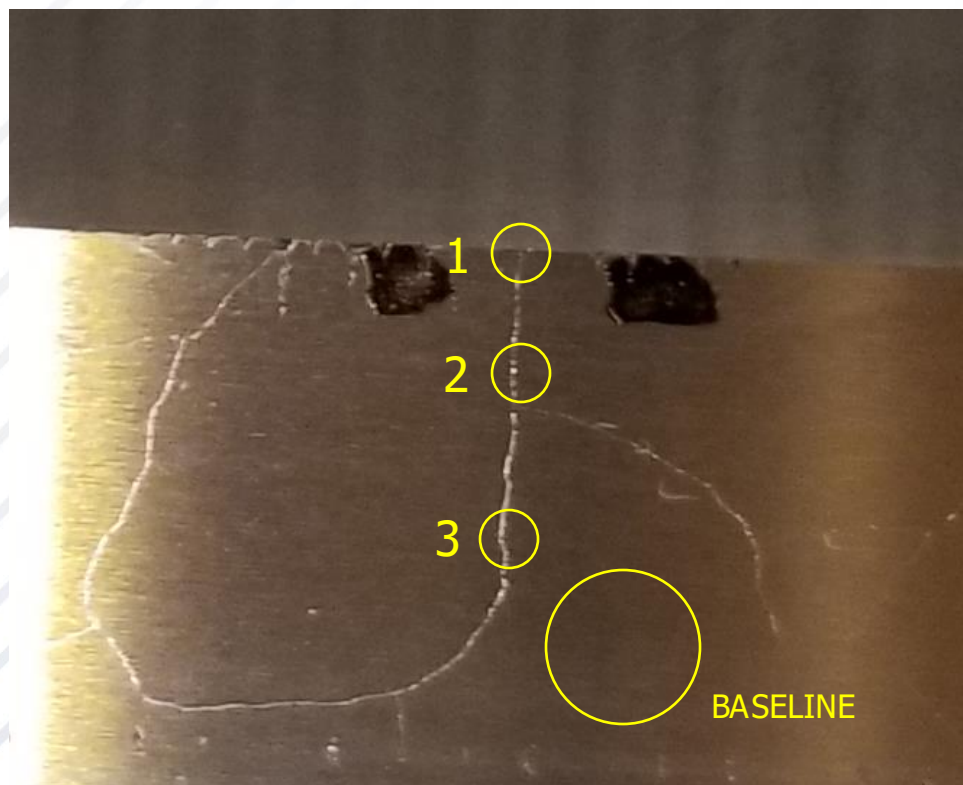
Post-Test: 3D Microscopy of Visible Cracks

Crack Depth Analysis – Lower Insert Results
The Post-Test scan points are in a slightly different location, with in 1-2mm of the Pre-Test scans.
