Using Direct Energy Deposition to Fabricate Trim Tools for Trimming AHSS

Auto/Steel
Partnership

Project Details

To evaluate the potential of using trim tools created using wire fed direct energy deposition (DED) additive metal process to trim advanced high strength steel (AHSS).

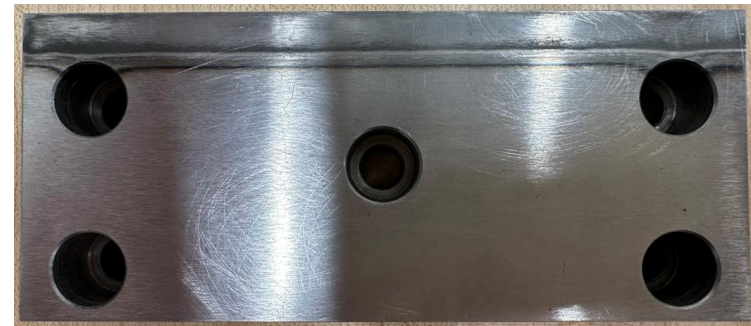
Laser hardened 4140 (machined from prehard bar stock) Trim Tool
